## ► CASE STUDY: VENEERING

### Keystone Walls With Native Rock Facing; A Beautiful Combination!

► **PROJECT:** Bachelor's Gulch

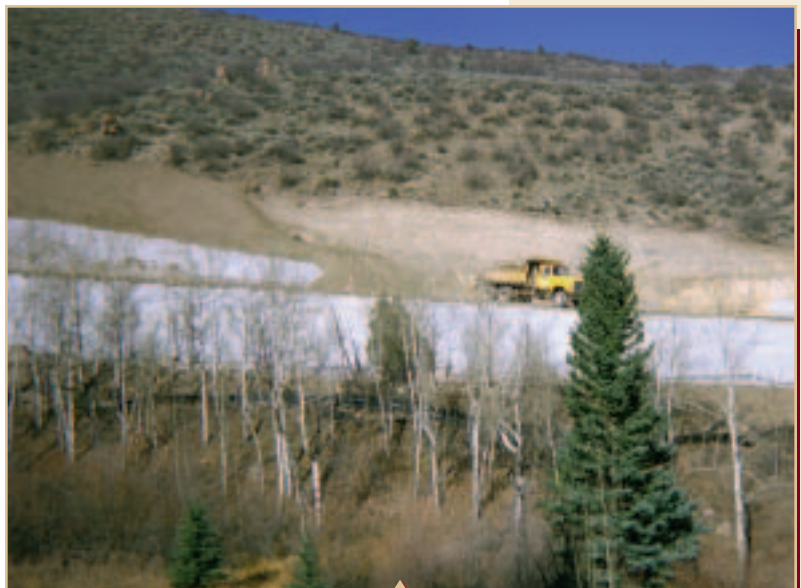
*View of completed wall prior to placement of moss stone veneer.*

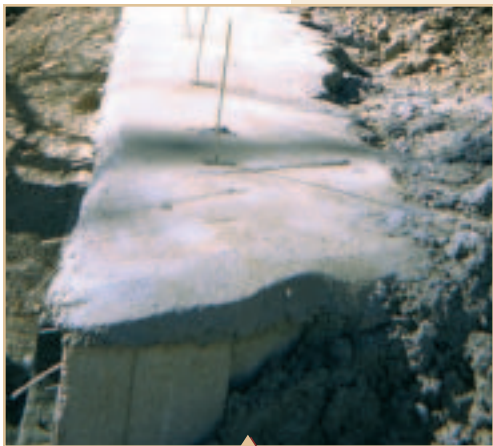
View of top of wall elevation showing grouted cap serving two purposes: (1) seal off water (2) secure wire to units and provide clean surface for rock attachment.

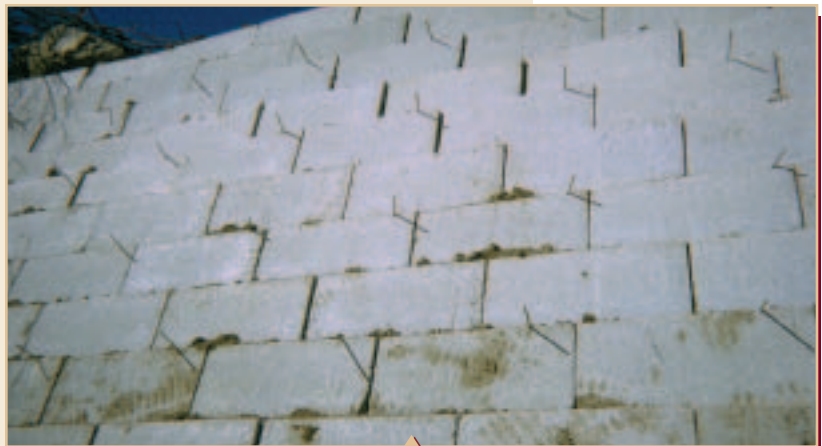
Straight face, unsplit KEYSTONE Standard units with a 9 gauge wire provided the surface and method for attaching the rock veneer.

Modifications for attaching the rock veneer to the Keystone units were relatively simple; but because of time constraints associated with the project and the time required to adjust the mold, the individual Keystone units were modified in the field. As the units were being placed on the wall, the contractor cut a groove large enough to accommodate a 9 gauge wire tie in every unit, every other course.
