Retaining Excellence™

The Metropolitan Plant Exchange

Fort Lee, New Jersey

CASE STUDY

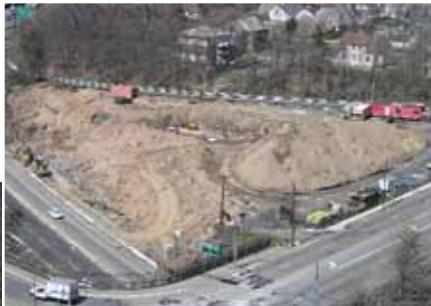
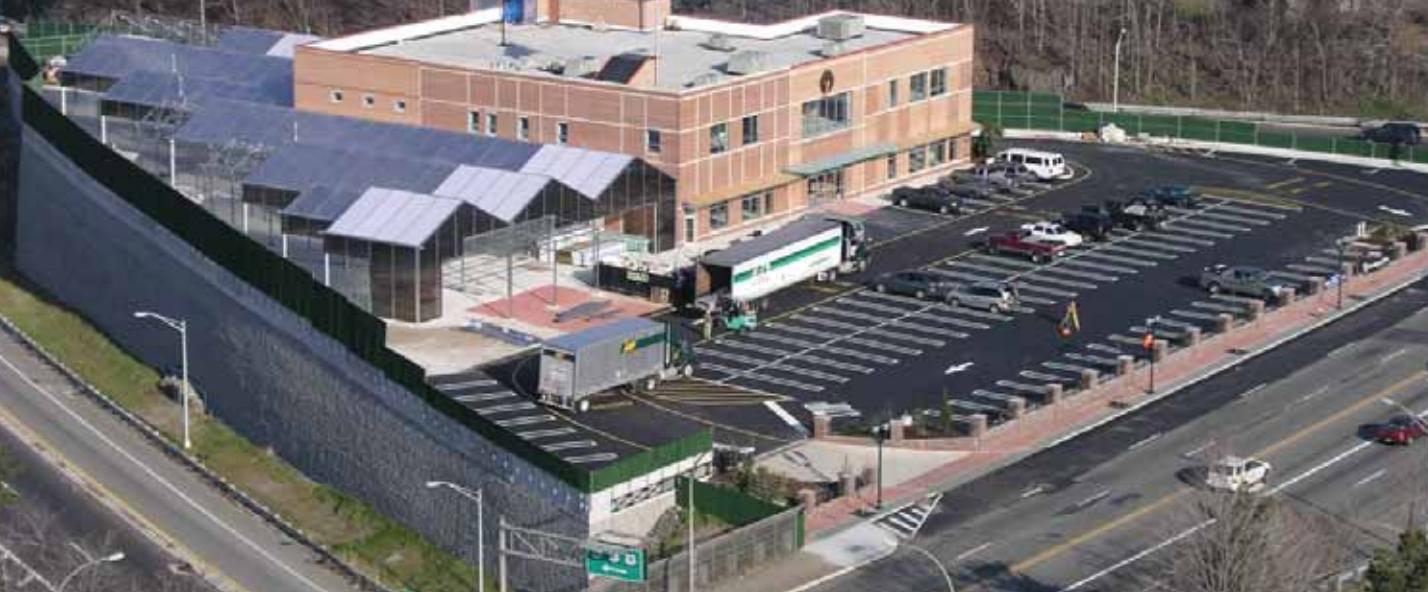
The Metropolitan Plant Exchange's site is located only a little more than 10 miles from New York City, at an intersection of major highways in downtown Fort Lee, NJ. To level the land, a 36' retaining wall

was to be built on the site's south side, an area with a 45° slope, rock outcroppings and related

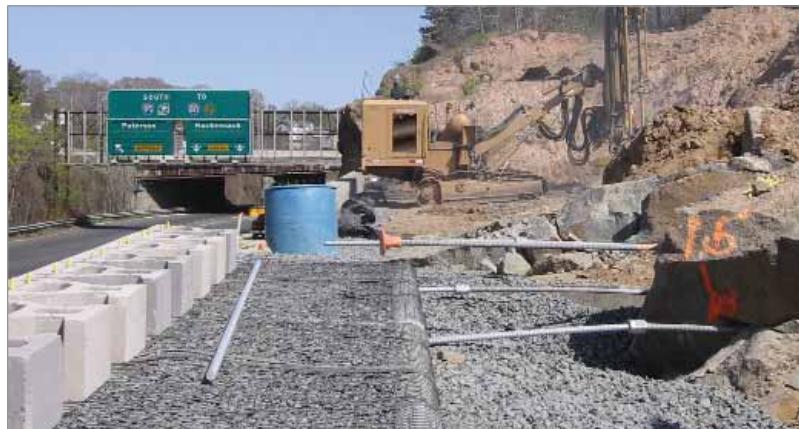
The presence of bedrock in many sections of the wall's reinforced zone prevented some geogrid from being placed at its required length. Rock anchors were used in these areas. More than 200 rock anchors were used at various elevations at the base of the wall. Some anchors were placed up to eight feet high on the wall. A five-inch diameter galvanized schedule 40 steel spreader pipe was drilled and fastened to the rock anchors.

According to Jon Hansberger, Engineer, Keystone Retaining Wall Systems, Inc., much of the remaining bedrock occurs at varying angles that produce additional forces exerted on the anchors and grid. The additional forces required extensive analysis that included a combination of hand and design software calculations. Also engineered was a length extension for the wall. The Keystone Victorian Stone wall system's flexibility allowed the wall to be extended to take advantage of additional parking space, however the extension required the execution of an acute angle. The engineered design solution combined the reinforcement grid and lean concrete to accommodate the 60° angled corner.
